ASSESSMENT OF COMPOSITE DELAMINATION SELF-HEALING VIA MICRO-ENCAPSULATION

To be published in Proceedings of
American Society for Composites
23rd Technical Conference
Memphis, Tennessee
Sept. 2008

ABSTRACT

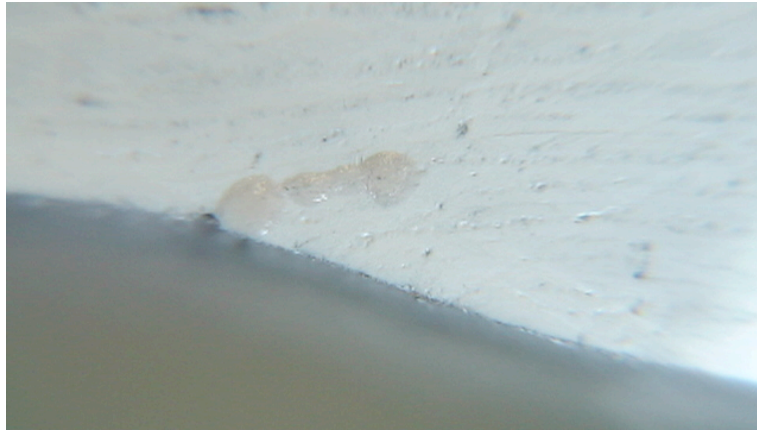
Upon removal from the three-point bend fixture, this specimen was clamped in reverse bending before re-loading (fig.11). The specimen remained clamped for 24 hours. Upon removal of the clamp, a residual curvature was evident. The original crack surfaces appeared to be closed, indicating that some healing may have occurred. In addition, healing was observed as evidenced by healing agent that leaked to the specimen edge forming a visible “scar” (fig.25).

Fig.25 Visible post clamp-up “scar” indicating healing in specimen 5-13
